FIRING RANGE BUSINESS CASE

JANUARY 2021

DOCJT FIRING RANGE BUSINESS CASE

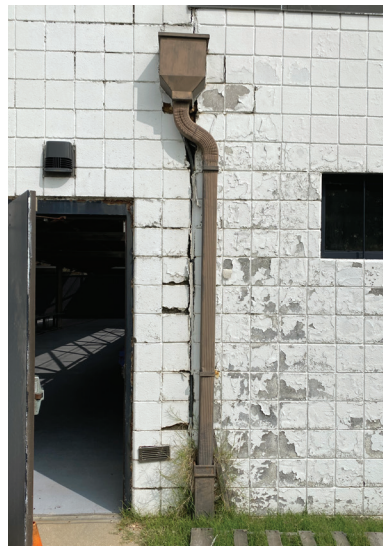
Image retaken September 2020, note CMU has continued to deteriorate.

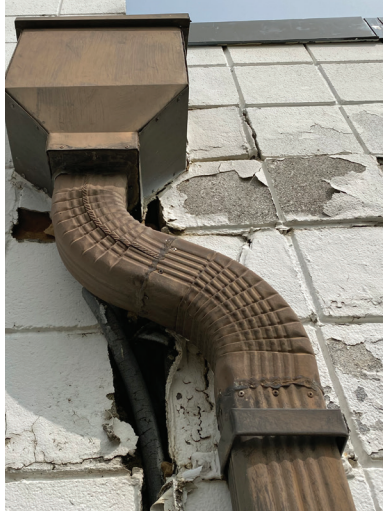
Enlarged image, exposed expansion joint and failing CMU at through-wall scupper

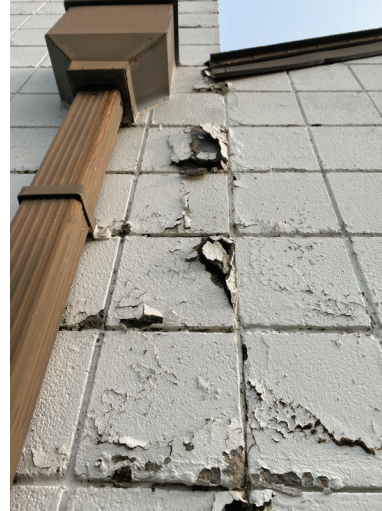
Paint and CMU spalled adjacent to through wall conductor head. Typ at most conductor head location, especially along South Facade

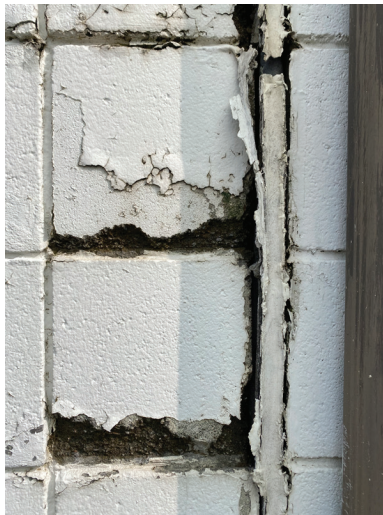
Enlarged image, lower section of expansion joint

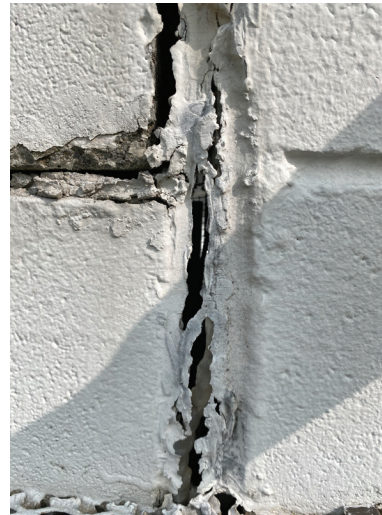
Failed CMU control joint, has opened up allowing moisture infiltration

There is an expansion joint between the semi-enclosed area and the conditioned one story section. **All of these joints have failed.**

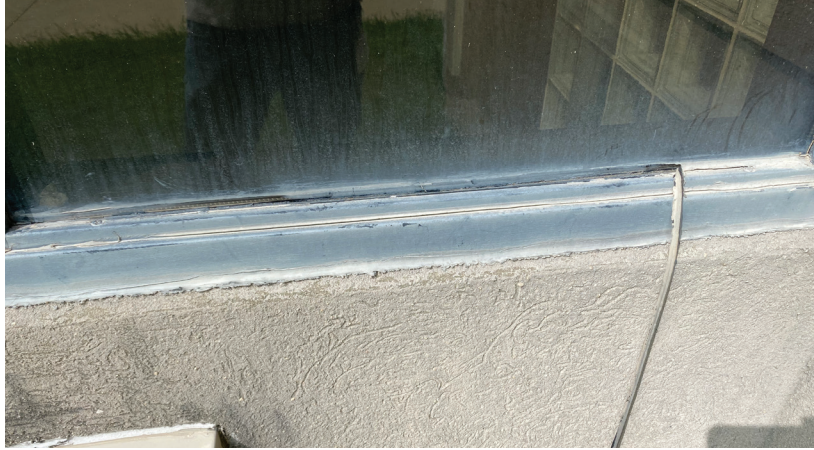
Failed previous repair attempt at hollow metal window

FENESTRATIONS: Hollow, metal-framed paint finish is chalking and many locations are exhibiting surface rust and spall. **Seals do appear to be an issue as previous repair attempts are failing.** Clear insulated glazing appears to be in good condition, but has low energy performance compared to today's options and **would not meet current energy codes.**

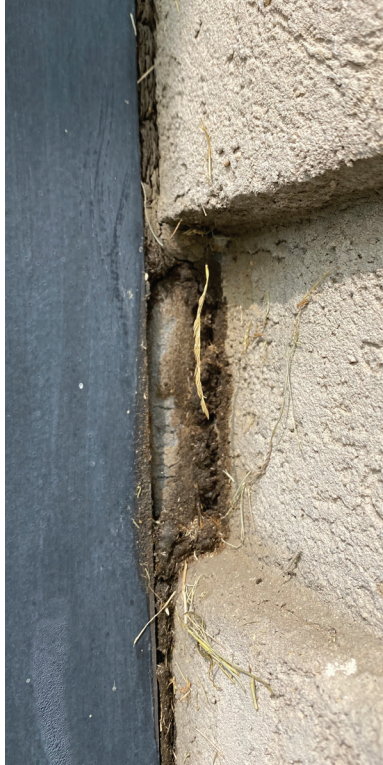
Front entry doors perimeter joint sealants have almost completely disintegrated

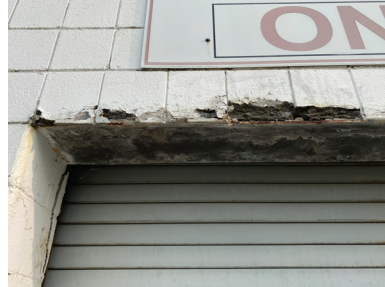
Overhead door lintel, CMU is in a heavy state of deterioration

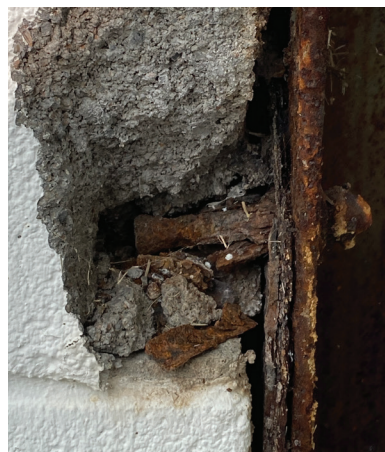
EXTERIOR OVERHEAD DOOR: Overhead Cornell door track anchors have spalled to the point that the surrounding CMU has cracked and chipped away. **This is a safety concern as there does not appear to be any track anchors that have not been severely compromised.**

Overhead door track anchors are all heavily corroded and spalling caused adjoining CMU to crack and chip away

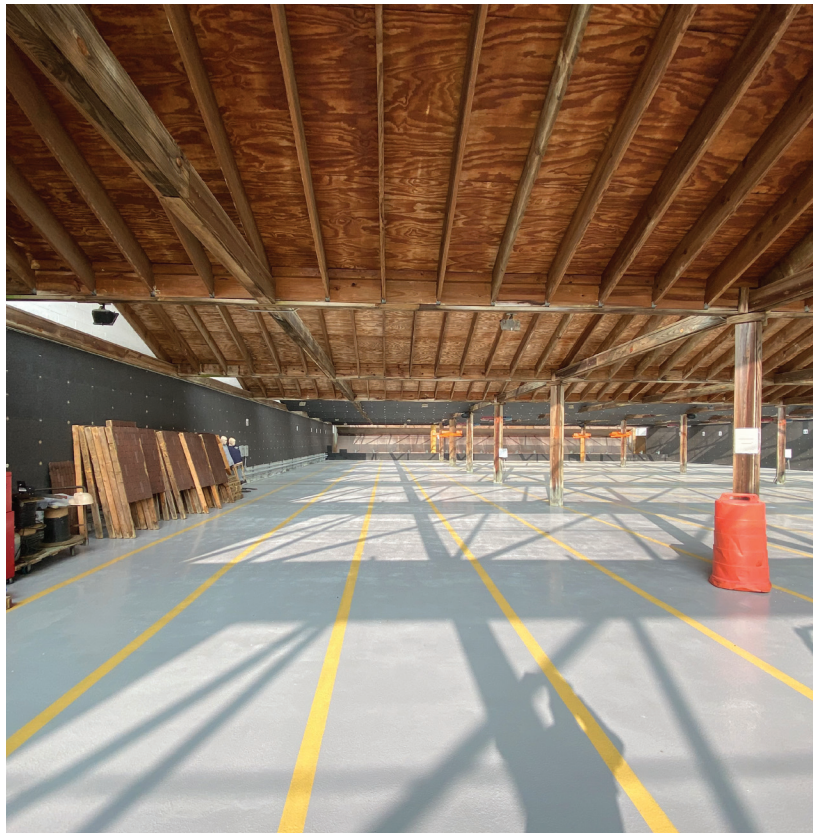
Underside of plywood roof deck

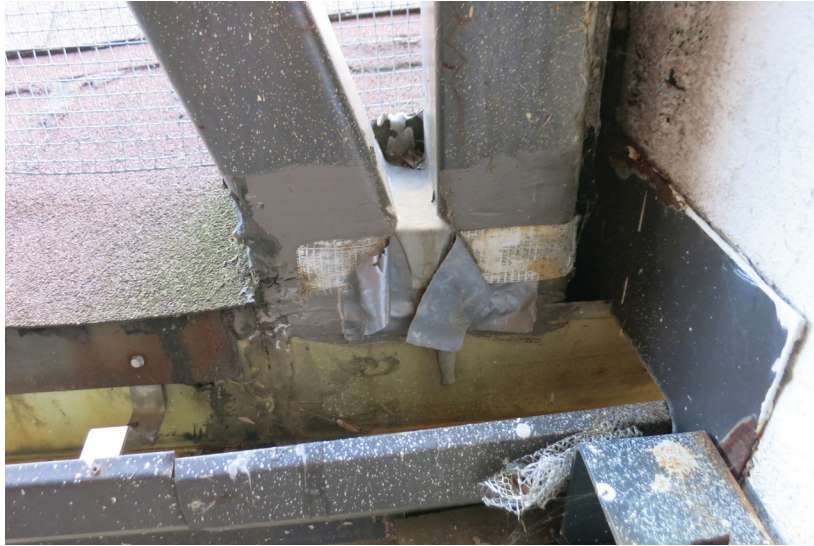
At the bottom of each saw tooth is a continuous gutter leading to a through-wall scupper and conductor head on each end. **Gutter was replaced at some point. Gutter is flat, undersized and mounted too low, allowing water to overshoot the gutter in a heavy rain event.** This has not caused any damage, as interior is a concrete floor and freely vents to the outside. **However, it does create a slipping hazard.** Open roof trusses with bird screen allow rain to enter the space during a wind-driven rain event from the east, which is not the prevailing wind direction. **Through-wall scuppers and conductor heads are in poor condition and are allowing water to infiltrate into the CMU.** Some downspouts are also damaged. One conductor head was full of water at time of inspection and it appeared that another downspout boot was clogged from adjacent soil erosion. Tower has a standing seam metal roof. It appeared from a distance to be in OK shape.

Gutter & through-wall scupper

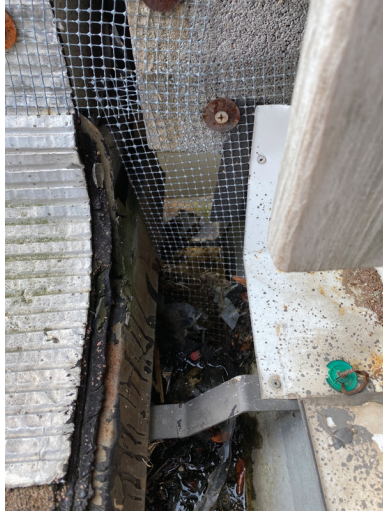
Gutter through-wall opening at expansion joint, which is allowing water infiltration into CMU wall, note joint is completely open on back side

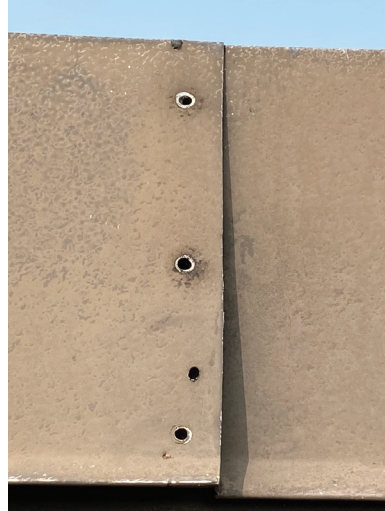
Note pop rivets have failed at top edge of roof flashing

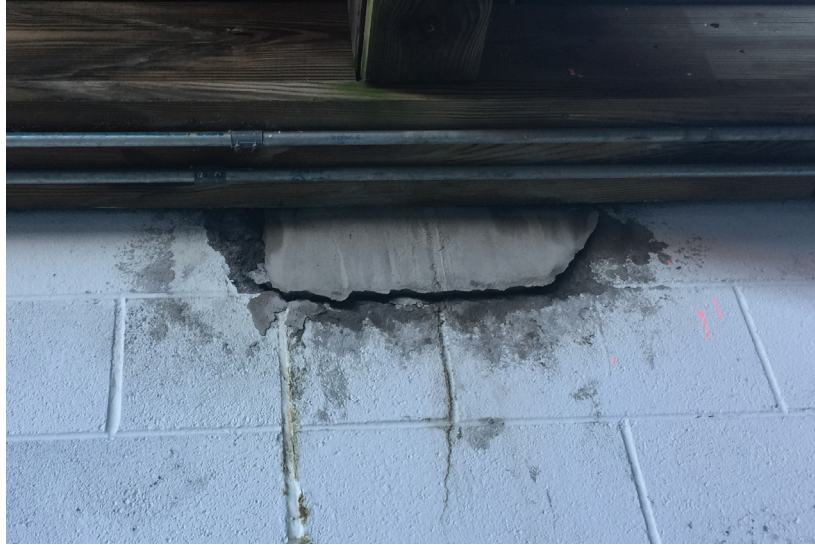
Failing CMU beam pocket repair

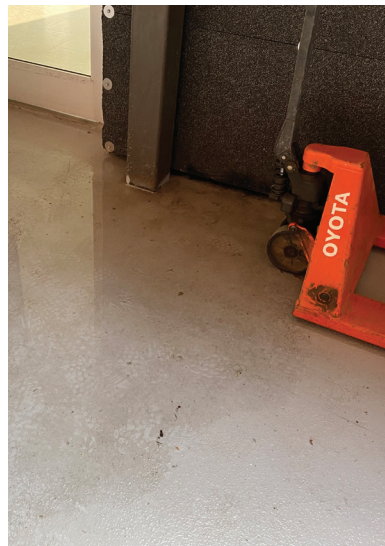
Ponding water on floor slab, due to leaking gutter and wind driven rain. Could be trip hazard through formation of ice in winter

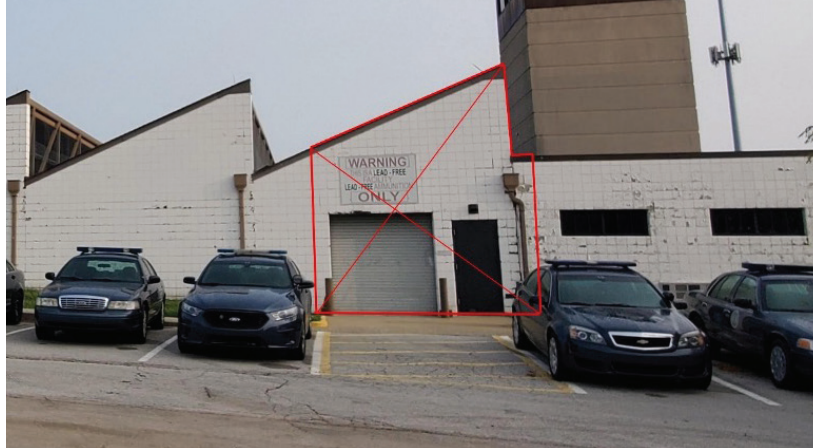
*Exterior concrete
masonry wall
reconstruction
extends*

EXTENSIVE WALL DETERIORATION: The deterioration is severe at the vertical control joint behind the rain water leader. It is less severe, but still significant and extensive, at the adjacent man door and overhead door located just to the west of the joint. At the joint, where the deterioration is most severe, the wall supports a steel roof truss. **There is potential for the wall to fail, leading to a catastrophic partial collapse of the adjacent roof structure.** It is

our opinion that the existing steel roof truss should be temporarily shored just inside the wall immediately and until the wall can be reconstructed.

The wall at the overhead door is also in very poor condition. While the potential for collapse is low, the potential for localized failure such as the overhead door to wall connection failing or pieces of masonry falling is high. It is our opinion that the overhead door should be disconnected temporarily until the wall is reconstructed, including a new lintel at the head of the opening. Upon completion of the masonry reconstruction, the overhead door should then be reinstalled.

The deterioration at the man door between the overhead door and the control joint is not severe. However, it is our opinion that the wall in this area will be easier to replace than to preserve during the reconstruction of the areas immediately adjacent on both sides. It is also our opinion that it will be easier and less costly to reconstruct the wall full height rather than to shore it and try to preserve the upper portions.

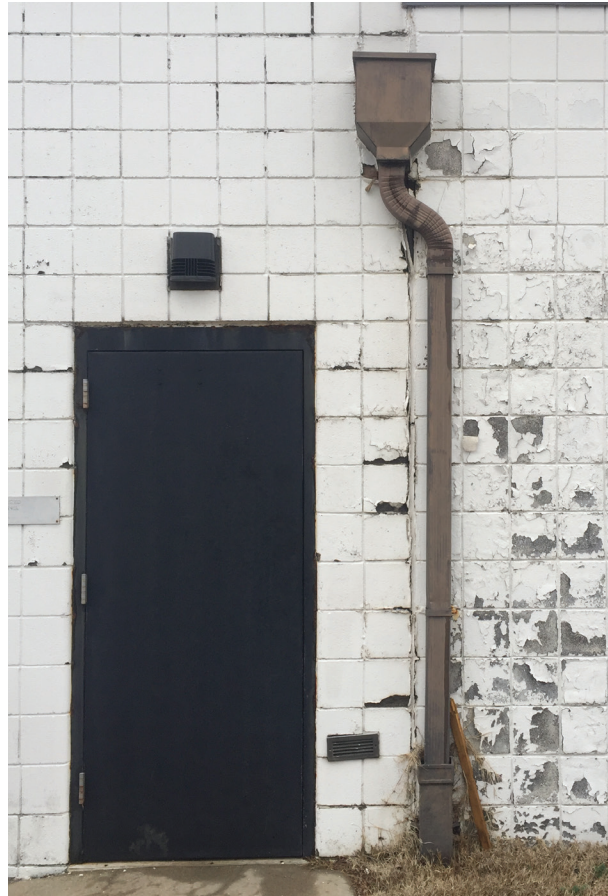
Severe deterioration at control joint
