FIRING RANGE BUSINESS CASE

JANUARY 2021

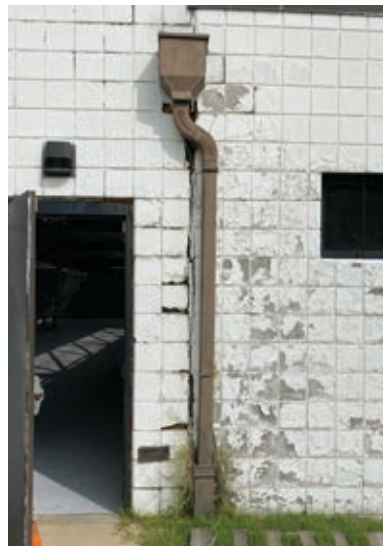
Image retaken September 2020, note CMU has continued to deteriorate.

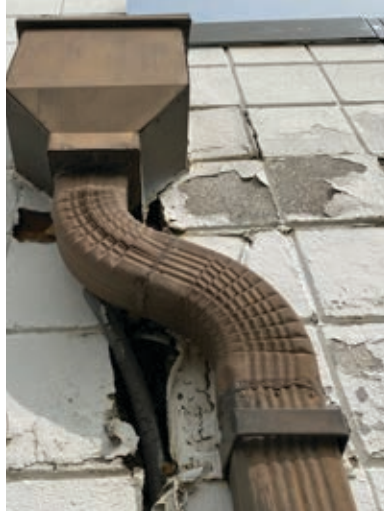
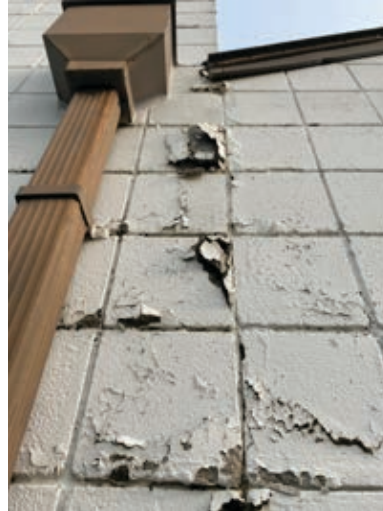
Paint and CMU spald adjacent to through wall conductor head. Typ at most conductor head location, especially along South Facade

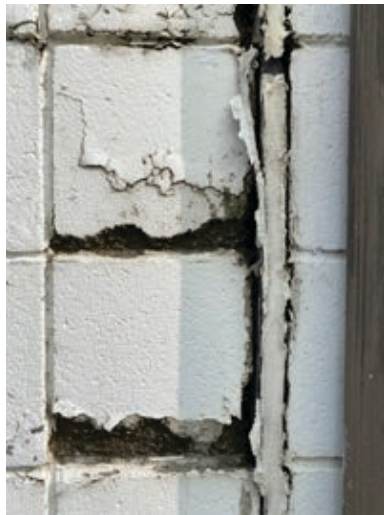
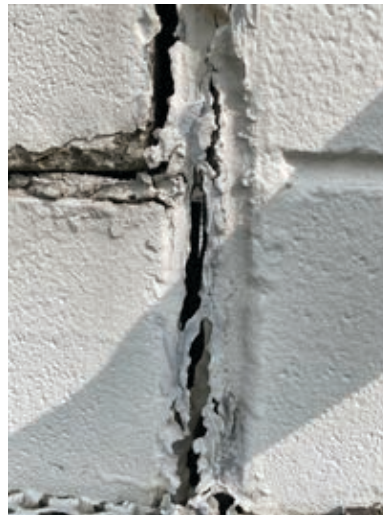
Failed CMU control joint, has opened up allowing moisture infiltration

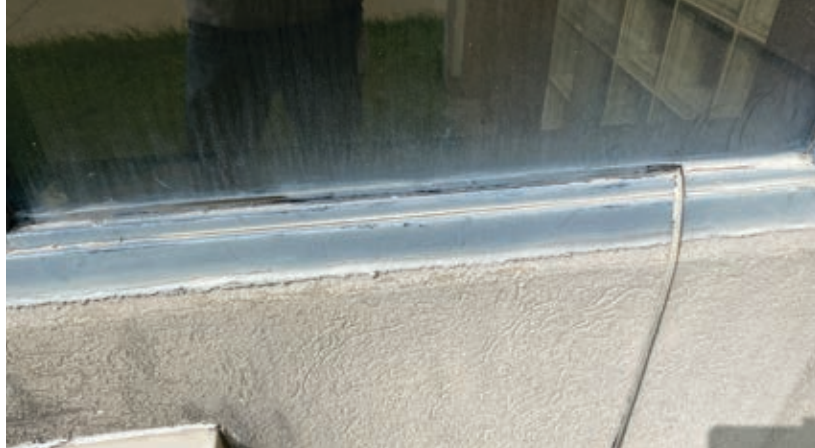
Failed previous repair attempt at hollow metal window

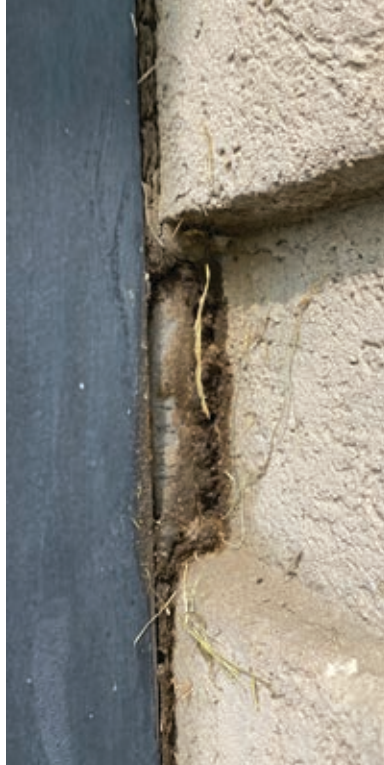
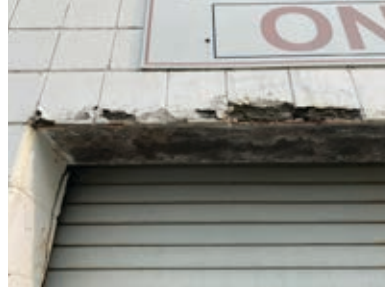
Overhead door lintel, CMU is in a heavy state of deterioration

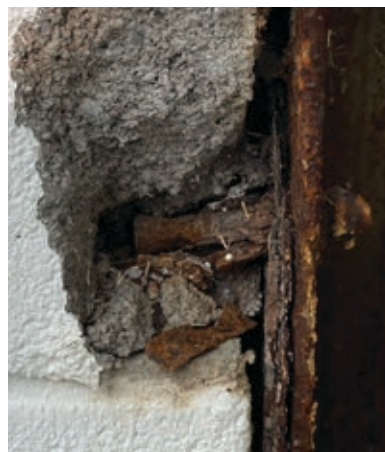
Overhead door track anchors are all heavily corroded and spalling caused adjoining CMU to crack and chip away

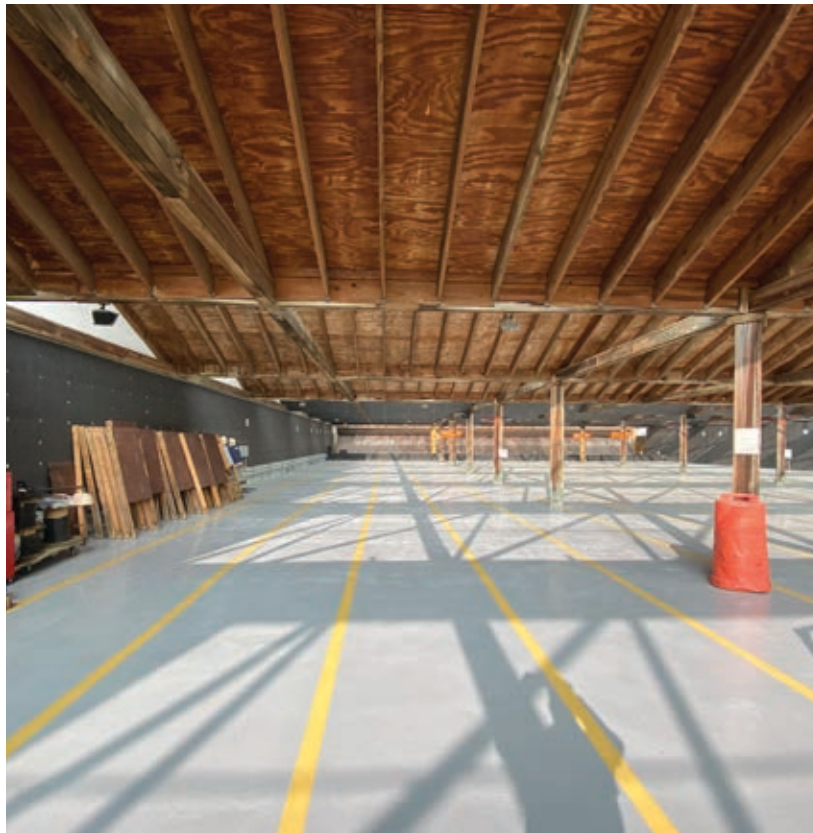
Underside of plywood roof deck

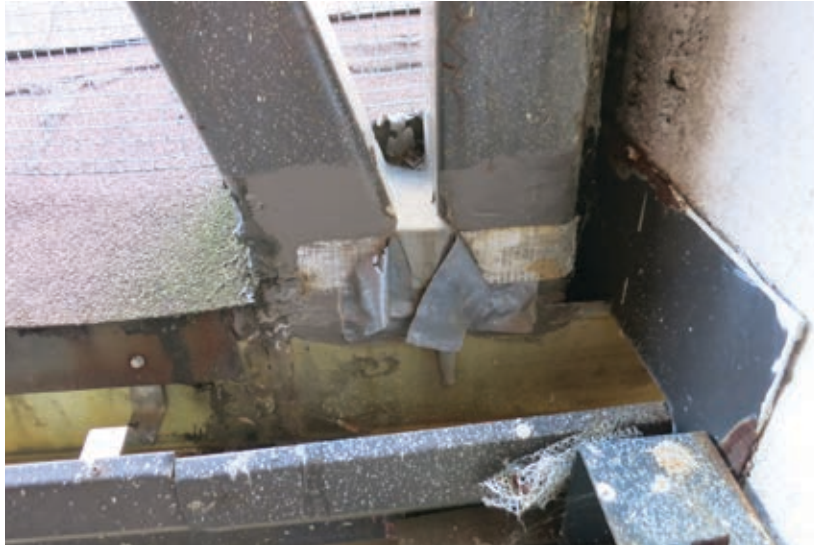
Gutter & through-wall scupper

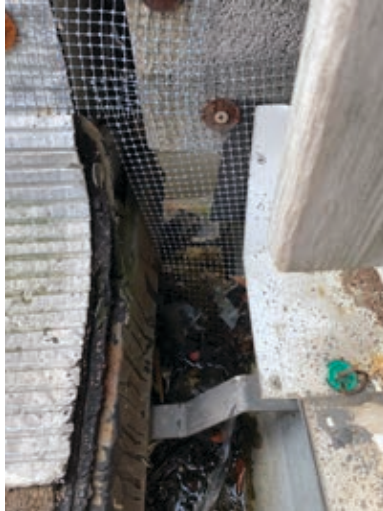
Gutter through-wall opening at expansion joint, which is allowing water infiltration into CMU wall, note joint is completely open on back side

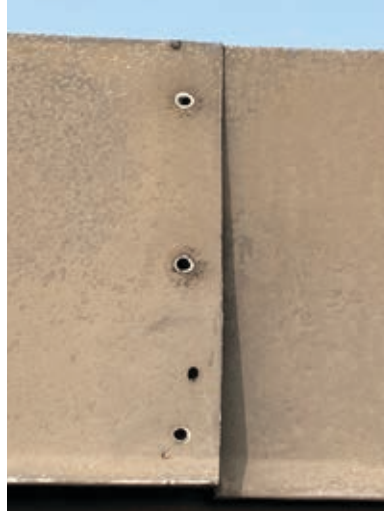
Note pop rivets have failed at top edge of roof flashing

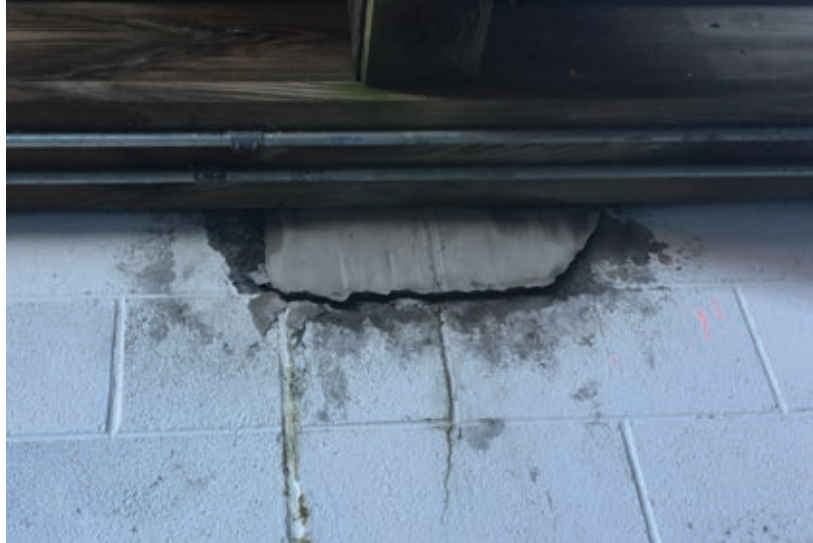
Failing CMU beam pocket repair

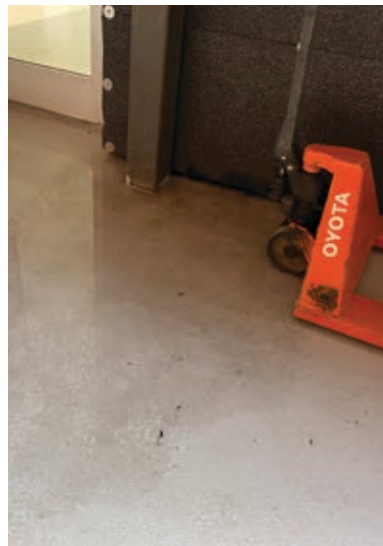
Ponding water on floor slab, due to leaking gutter and wind driven rain. Could be trip hazard through formation of ice in winter

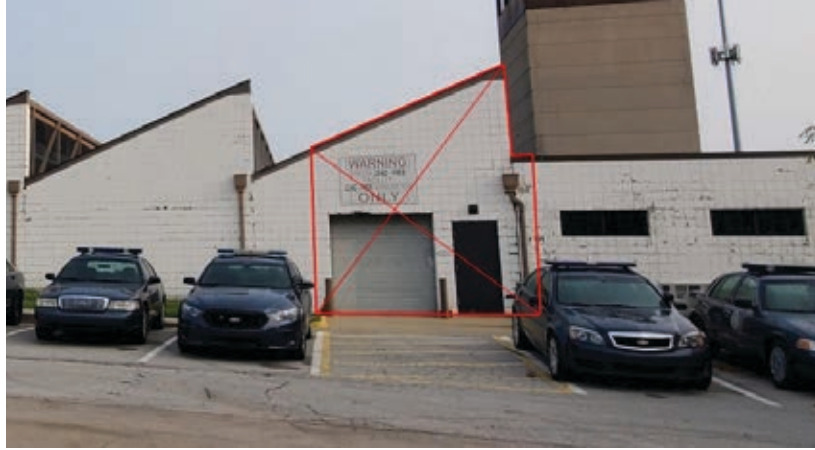
EXTENSIVE WALL DETERIORATION: The deterioration is severe at the vertical control joint behind the rain water leader. It is less severe, but still significant and extensive, at the adjacent man door and overhead door located just to the west of the joint. At the joint, where the deterioration is most severe, the wall supports a steel roof truss. **There is potential for the wall to fail, leading to a catastrophic partial collapse of the adjacent roof structure.** It is

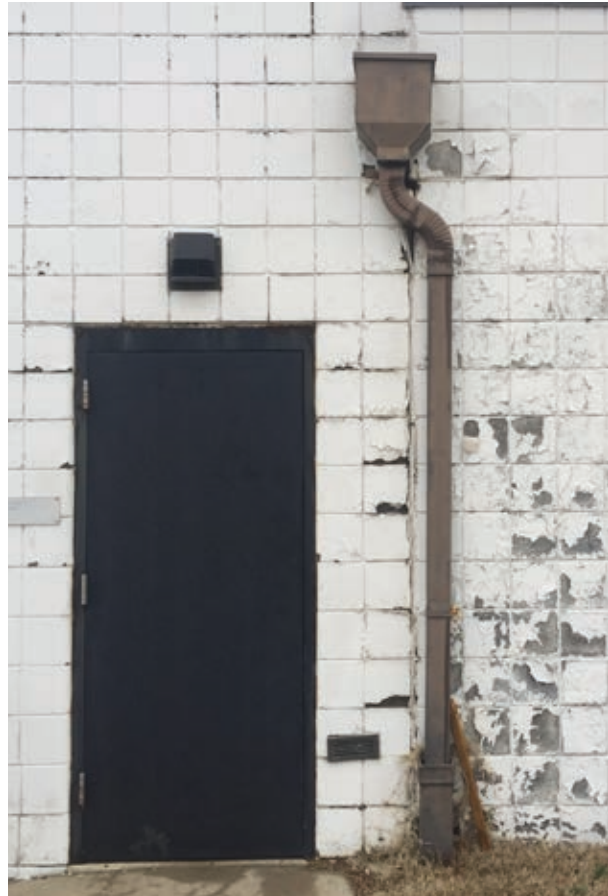
Severe deterioration at control joint
